HOME INSPECTION REPORT

Buyer's New Street
New Town, PA 00123

Prepared for: New Home Buyer

Prepared by: Profile Inspections, LLC
7 Colton Drive
Plymouth Meeting, PA 19462

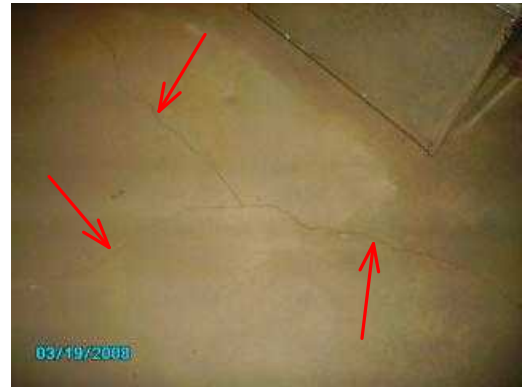
- 1. Acceptable Ceiling: Exposed framing
- 2. Acceptable Walls: Concrete
- 3. Marginal Floors: Concrete - Crack/s

4. Main Basement Floors: Concrete - Crack/s
