# HOME INSPECTION REPORT

Buyer's New Street  
New Town, PA 00123

Prepared by: Profile Inspections, LLC  
7 Colton Drive  
Plymouth Meeting, PA 19462

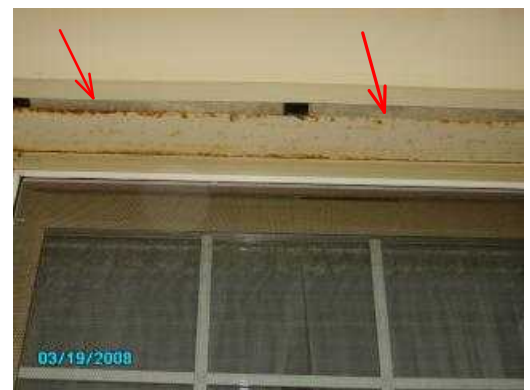
- 2. Acceptable      **Type:** Stone veneer - Moisture stains on stucco below windows at Southwest elevation
- 3. Acceptable      **Trim:** Wood - Keep all wood trim caulked at joints and painted
- 4. Acceptable      **Fascia:** Aluminum
- 5. Acceptable      **Soffits:** Aluminum
- 6. Marginal        **Lintels Steel** - Lintels above windows at garage are rusting and will need to be prepped and painted

1. Lintels Steel - Lintels above windows at garage are rusting and will need to be prepped and painted

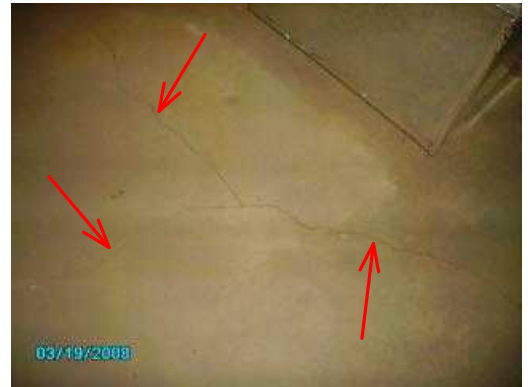
| 3. Marginal | Floors: Concrete - Crack/s |

4. Main Basement Floors: Concrete - Crack/s
